Measurement Notes

Note 61

Windscreen Shield Monitoring Using a Spiral Transmission Line

Everett G. Farr, W. Scott Bigelow, and Leland H. Bowen
Farr Research, Inc.

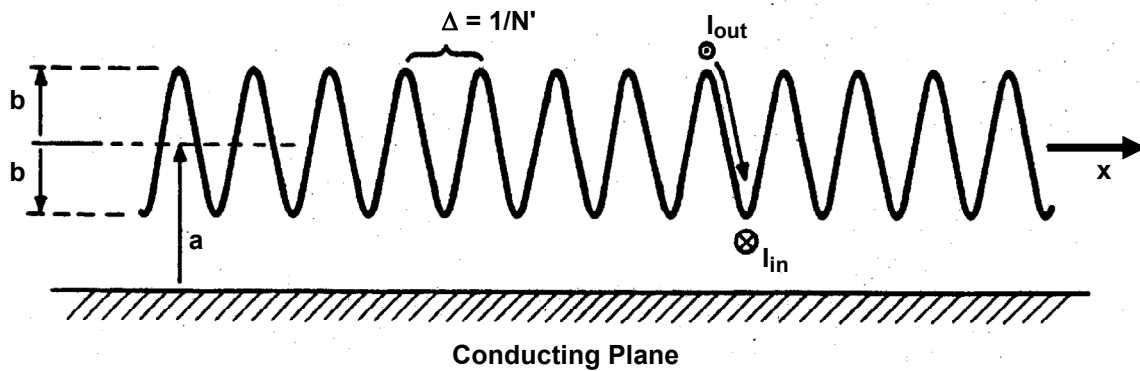
A. Side View

B. End View

Figure 3. Spiral Transmission Line, from [2].

We consider now the properties of STLs, because they are used in our new test methods. These methods are based on the SPIRA concept described by C. E. Baum in [2]. A sketch of an STL is shown in Figure 3. They are fabricated from a coil of insulated wire, positioned very close to the ground plane, to form a slow-wave transmission line.

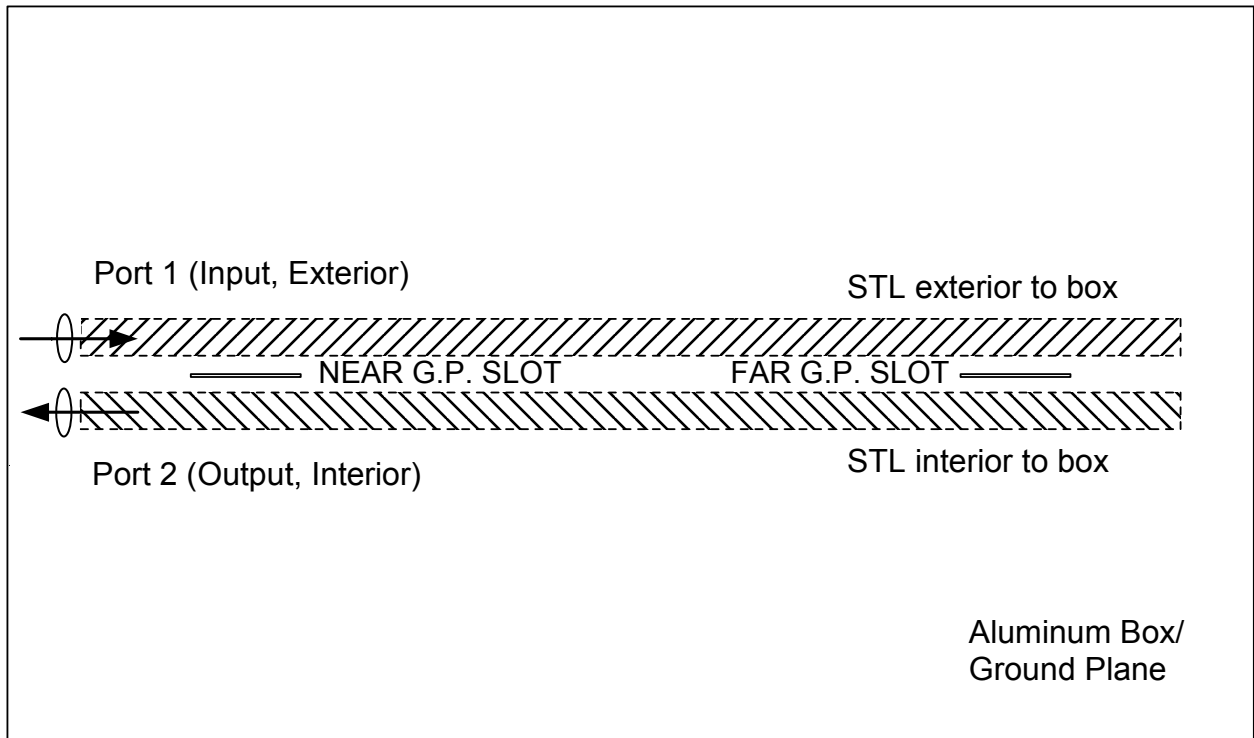
Figure 5. Layout of the dual STL measurement.

We describe first the experiments with dual STLs. We investigated whether it was possible to detect a leak, and if so, whether we could determine its position. Sketches of this configuration are shown in Figures 5 and 6, and photos are shown in Figure 7-9.

The conducting box had two slots, whose position we determined based on the time delay of the received signal. The two slots were designated as “Near Slot” and “Far Slot,” and were located close to the ports and loads, respectively. Both slots could be either open (leaky) or closed with copper tape, depending on the experiment. The top of the box acted as a ground plane for both the interior and exterior STLs.

First, we consider characteristics of the conductive box. The dimensions of the box were 42.7 x 25 x 13 cm, and all seams were sealed with copper tape to prevent leakage. Two slots were cut into the ground plane, running parallel to the STLs. Each slot was 38 mm x 1 mm in size. The center-to-center separation between the two slots was 26.15 cm.

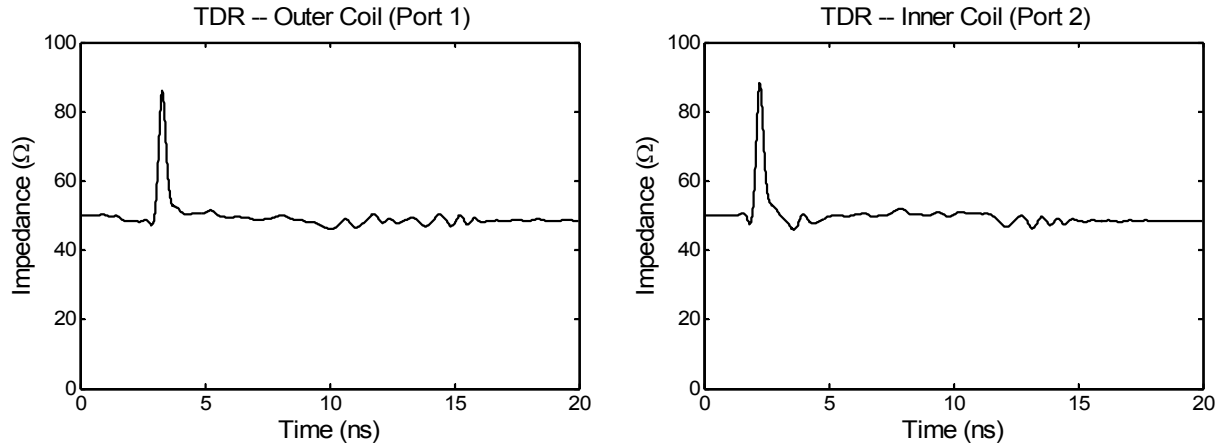
Figure 10. TDR of Port 1 (left) and Port 2 (right).

We now consider the time domain results of the dual STL experiment. First, we measured the TDR of the two STLs, with both slots closed. For this, we used a Tektronix model TDS8000 sampling oscilloscope with 80E04 sampling head. After taking the data, we applied a fourth-order lowpass filter, with a 3 dB frequency of 2 GHz, and the results are shown in Figure 10. We hoped to realize a flat 50- Ω impedance profile, and that is approximately what we do see. Note that the impedance of the transmission line is actually 180 Ω , but it looks like 50 Ω because of the 68 Ω shunt resistor. Note also that there are discontinuities near both Ports 1 and 2, at the beginning of both STLs. We went through several iterations to reduce these, and this is the best we obtained.

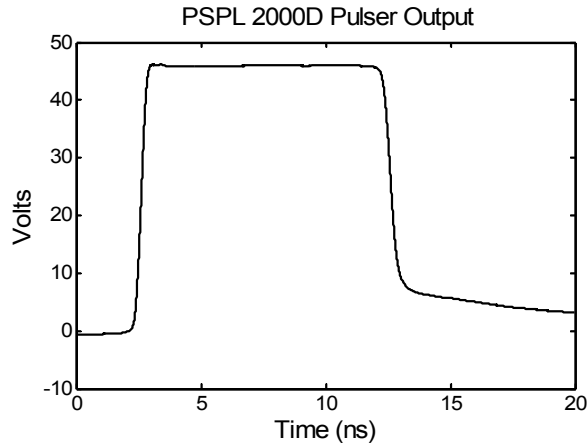
Figure 11. The output voltage of the PSPL model 2000D pulser.

Next, we detected fields leaked through the near and far slots. We drove Port 1 with a Picosecond Pulse Labs model 2000D pulser, whose output voltage is shown in Figure 11. It has a peak voltage of 45 V, a risetime of 350 ps, and a flat top for 10 ns. We then detected the signal at Port 2 under three conditions: both slots closed, Near Slot open, and Far Slot open. The measured waveforms are shown in Figure 12.

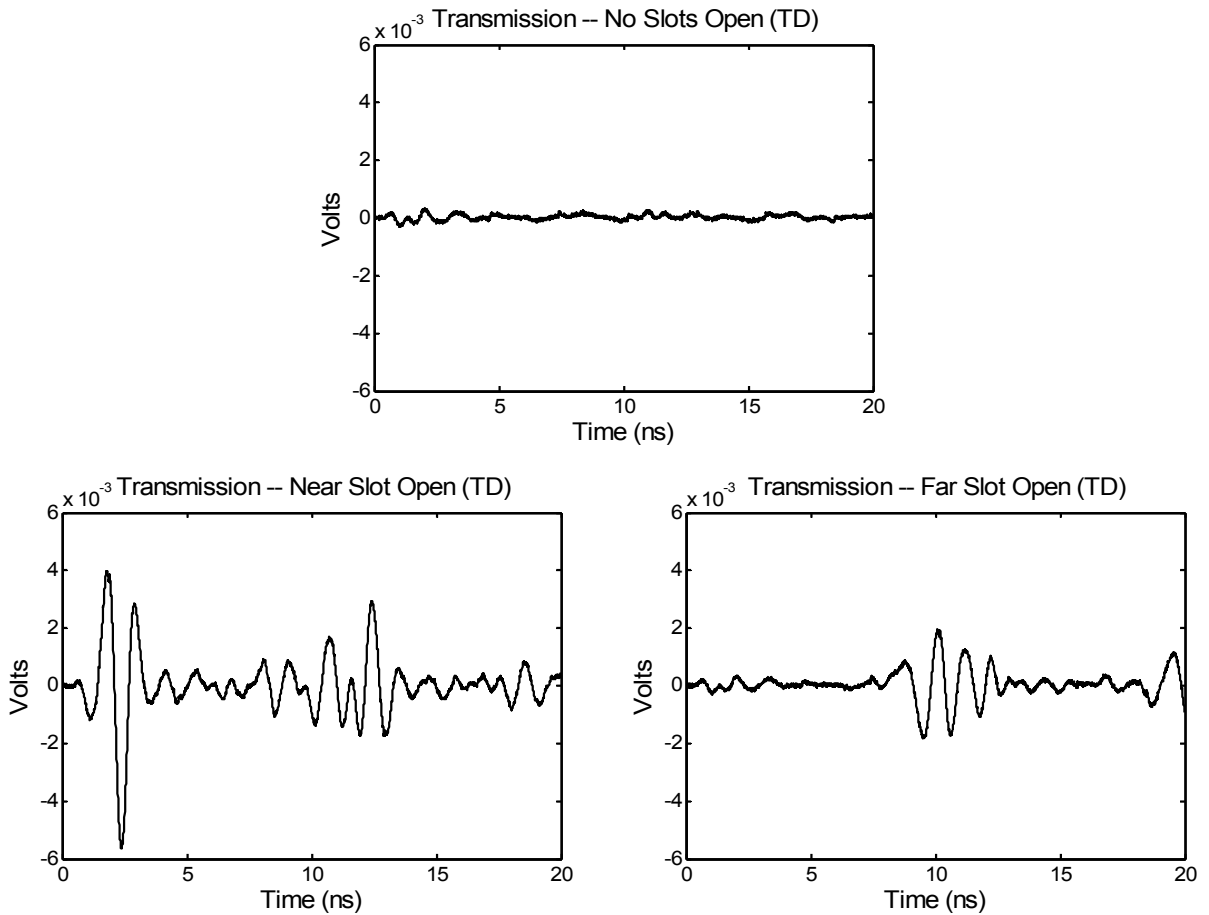
Figure 12. Leaked fields in the dual STL fixture, with both slots closed (top), Near Slot open (left), and Far Slot open (right). The peak signal occurs at 2.4 ns, with the Near Slot open, and 10.2 ns with the Far Slot open, resulting in a 7.8 ns time difference.

From the data, we see that with both slots closed, there is no signal detected at Port 2. However, with either slot open, there is a clear leakage signal detected at Port 2. The peak signal occurs at different times for the two slots – 2.4 ns when the Near Slot is open, and 10.2 ns when the Far Slot is open. Thus, there is a 7.8 ns difference in time of arrival.

Continuing the calculation, the slots are separated by 7.8 ns round-trip on the TDR, or 3.9 ns one way. This implies that their center-to-center separation is $3.9 \text{ ns} \times 6.7 \text{ cm/ns} = 26.1 \text{ cm}$. From the physical dimensions of the box, the center-to-center separation of the slots is 26.15 cm, so we are accurate to within about 0.2%.

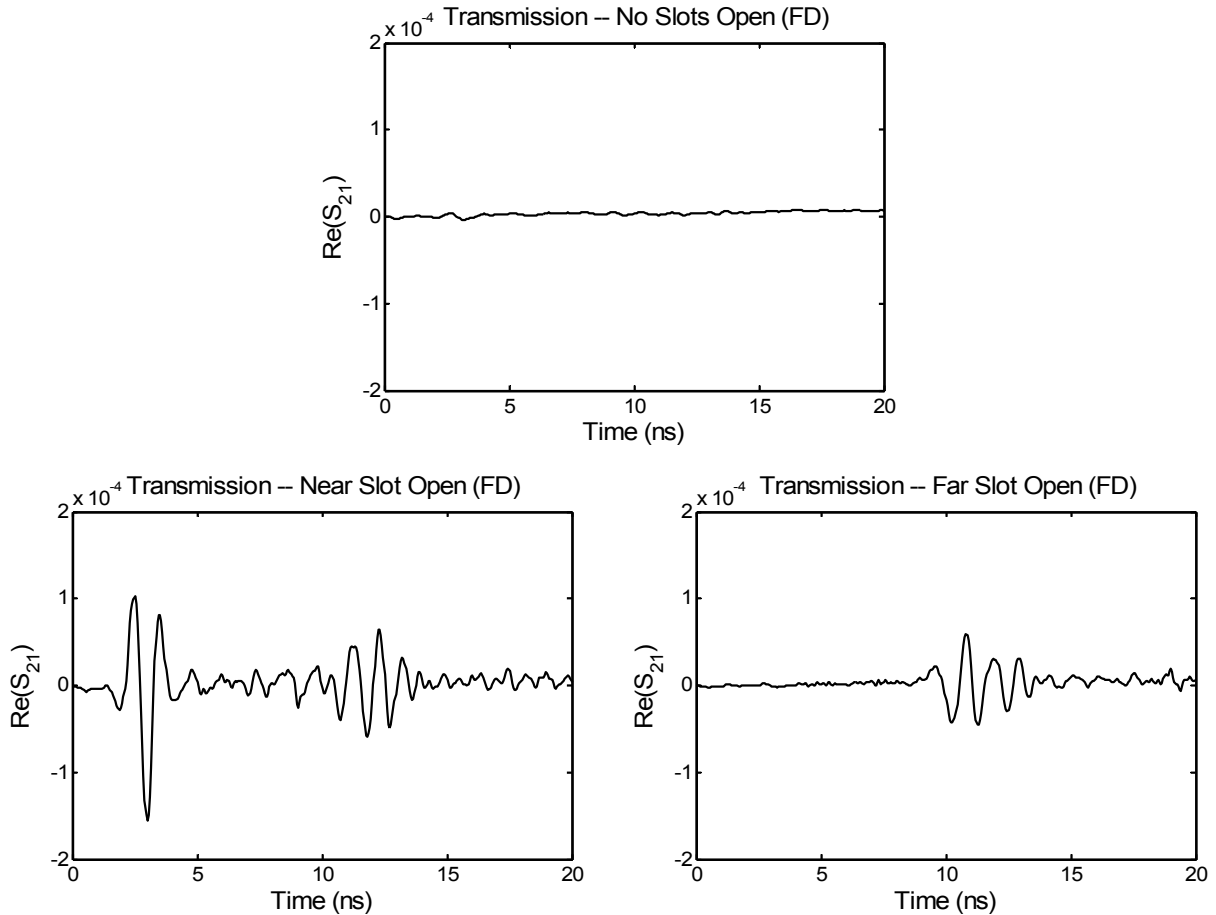
Figure 13. Leaked fields in the dual STL experiment using the time domain option on a VNA; both slots closed (top), Near Slot open (left) and Far Slot open (right). Note the similarity to the previous figure.

We next tried the same measurement in the frequency domain, using a Vector Network Analyzer (VNA) with time domain option (Agilent model 8753ES). We took data over a broad range of frequencies, and then used the internal FFT routines to convert the frequency sweeps to the time domain. The resulting time domain waveforms are shown in Figure 13, for three cases: no slots open, Near Slot open, and Far Slot open. As before, the time difference between the two signals is about 7.8 ns. Furthermore, the shape of the resulting time domain curves is very similar to those of Figure 12.

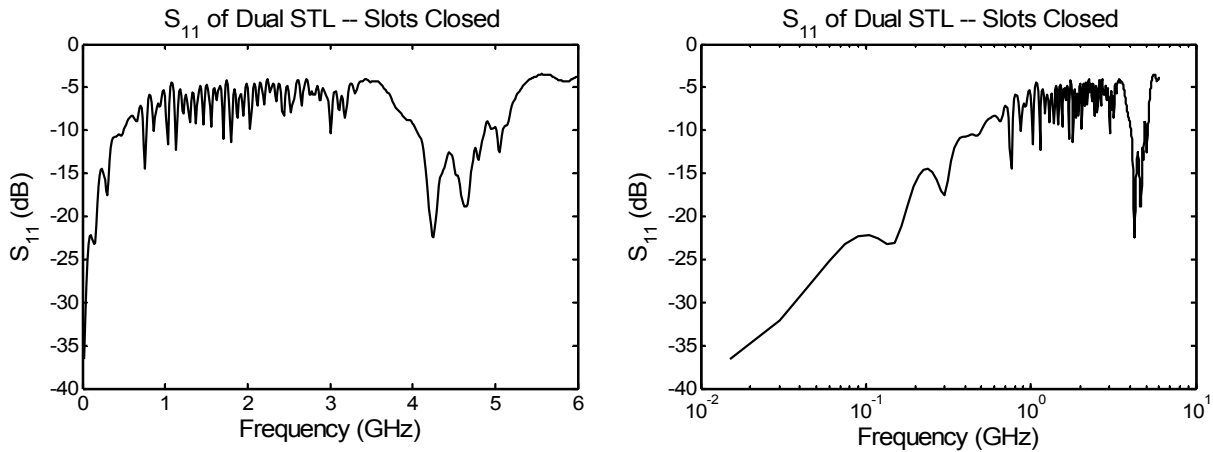
Figure 14. Return loss (S_{11}) of Port 1, with both slots closed.

We also took some conventional data with a VNA in the frequency domain. First, we measured the S_{11} of Port 1 with both slots closed, as shown in Figure 14. We see that the return loss is around -6 dB or better below 450 MHz.

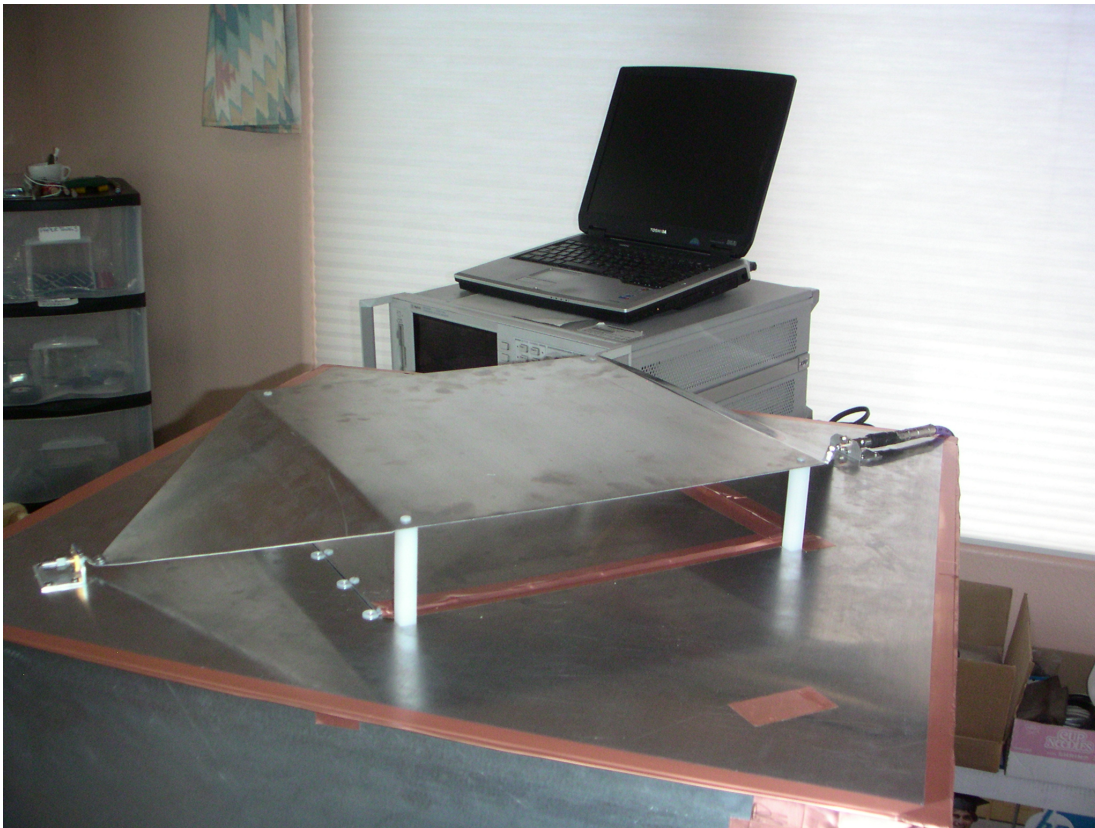
Figure 17. Exterior of the box, showing the stripline (or “blanket”), terminated in 50 Ω .

The steel box was a 2-foot cube, covered by an aluminum sheet with a 22.9 x 27.9 cm (9" x 11") window that was either leaky or sealed (open or closed). We drove the exterior of box with a stripline terminated in 50 Ω , as shown in Figure 17. We detected fields on the interior with an STL operating in differential mode with a balun (Prodyn model BIB-100F, 200 kHz–3.5 GHz), as shown in Figures 18 and 19. Our VNA measured the leakage signal (S_{21}), where Port 1 drove the stripline, while Port 2 detected the signal leaked to the interior. We compared the leakage signal for open and closed seams over 0.2–200 MHz.

On the exterior of the box was a stripline with dimensions 30 x 30 cm, positioned 6 cm above the ground plane. This was supported on four nylon posts located near the corners of the window opening. Triangular sections provided smooth tapers to points on the ground plane located 65 cm apart, where SMA connectors were mounted. Thus, along with the ground plane, the stripline formed an approximate 50- Ω transmission line.

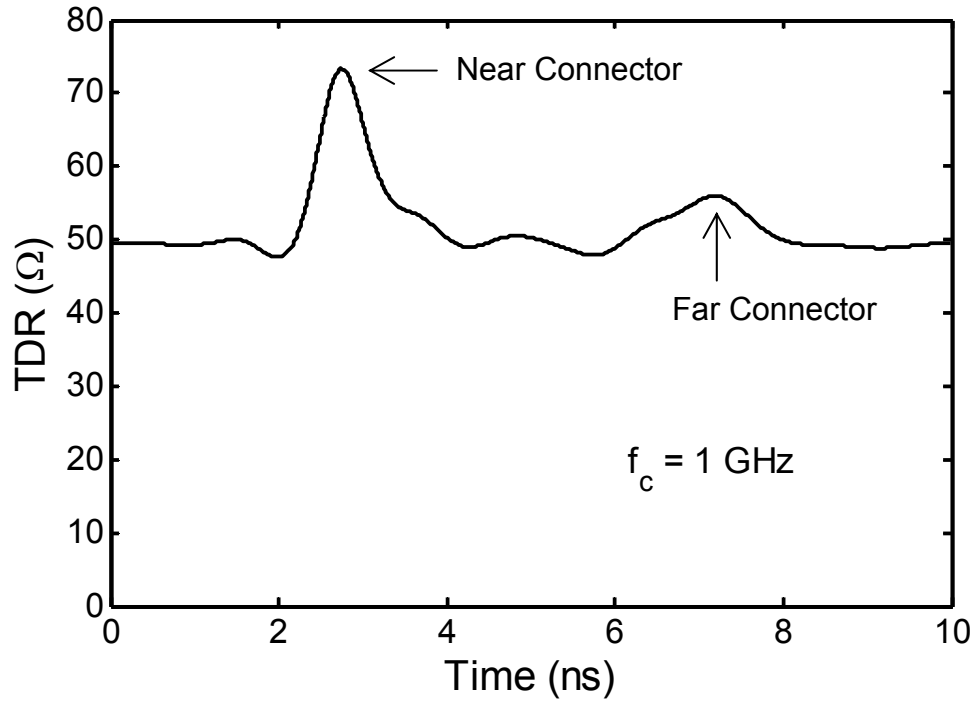
Figure 20. TDR of the stripline.

First we recorded the TDR of the stripline, as shown in Figure 20. This was filtered with a fourth-order lowpass filter with a cutoff frequency of 1 GHz. We hoped to see a flat 50 Ω , and that is approximately what we observe. However, there was some deviation at the SMA connectors. We estimate that this had little effect on the experiment.

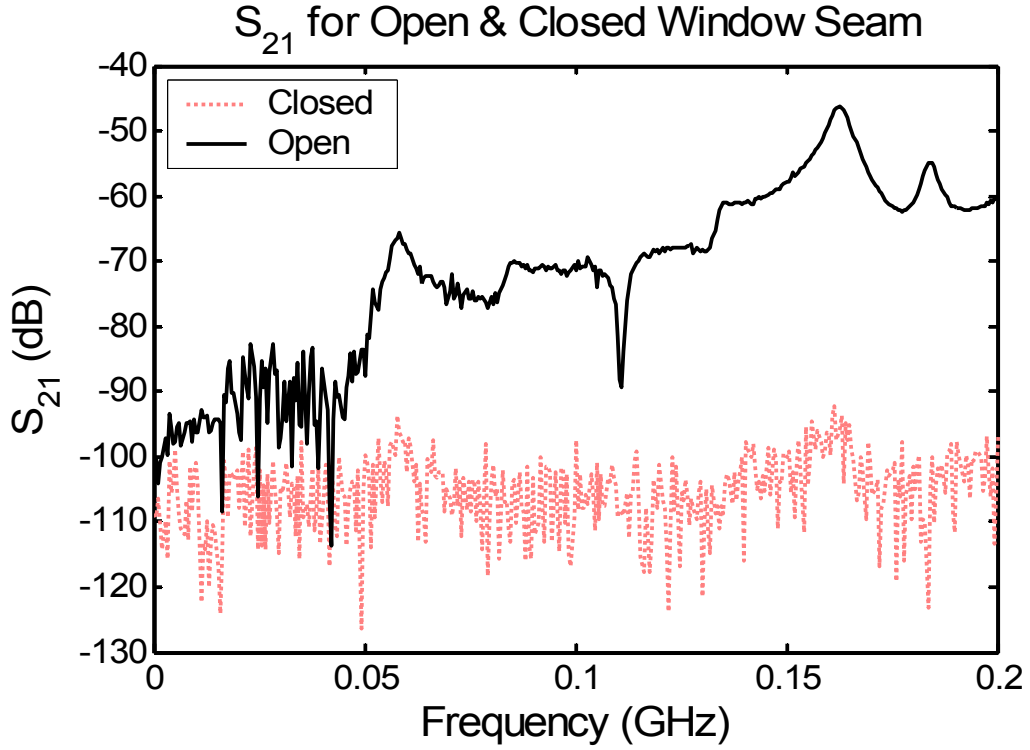
Figure 21. Comparison of leakage signals for open and closed window seams.

Next, we tested for leakage with the seam opened (leaky) and closed, and our results are shown in Figure 21. We observed a 30-40 dB difference in signal between the open and closed configurations over 50-200 MHz. These data demonstrate the effectiveness of the proposed method.

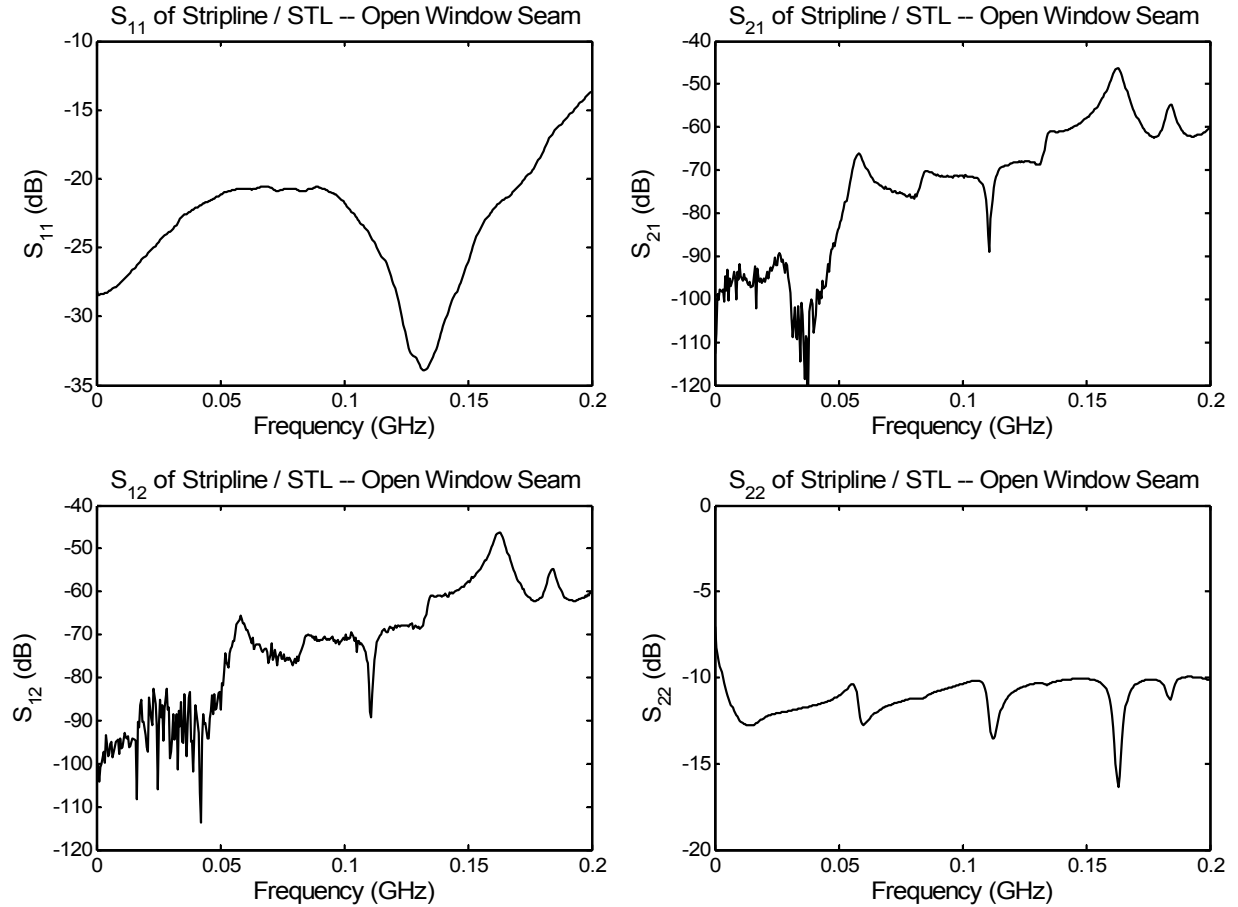
Figure 22. Plots of all four S-parameters for a leaky window. Clockwise from upper left, S_{11} , S_{21} , S_{22} , and S_{12} .

Finally, we recorded all four S-parameters, as shown in Figure 22. We observe that resonances in the S_{21} measurement of Figure 21 also appear in the S_{22} measurement of Figure 22. This indicates that the resonances in Figure 21 are coming from the STL – not the stripline. We should try to eliminate these resonances, if possible, in future experiments.
